LISBOA 2010 MAY 25/28 16th World Meeting

Ivan Legac, Hrvoje Pilko, Nikola Šubić
University of Zagreb - Croatia

Introduction of Roundabouts in Croatia – - preliminary Experiences

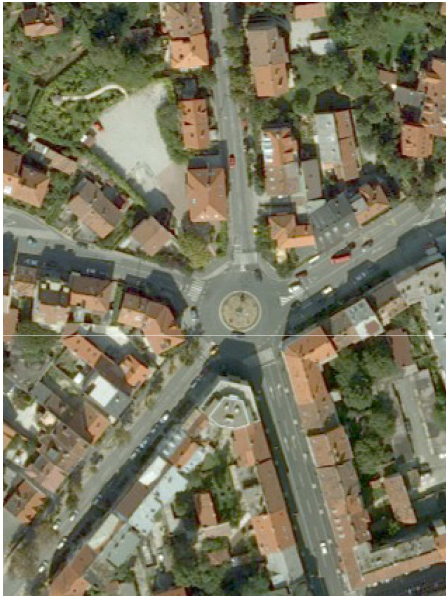
Figure 1. One of the oldest roundabout (Petr. – Domj. Str. in Zagreb, 1950)

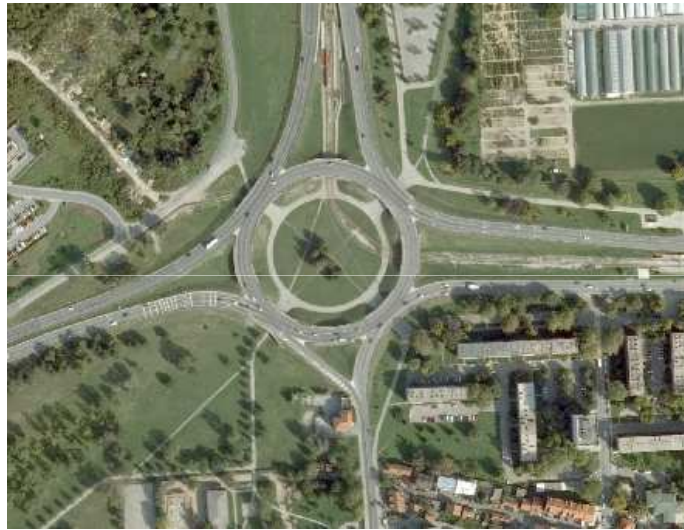
Figure 2. Big roundabout ($D_v = 148$ m, $n = 3/3$)
Jadr. Ave. – Remet. Str. at entrance in Zagreb, 1980.

a) Jadran. Ave. - Remet. Str.

Jadranska Av. - Remetinečka Street				
TYPES OF TRAFFIC ACCIDENTS	2008. y.	2007. y.	2006. y.	
1. Car-pedestrian collision	0	2	0	
2. Failure to yield at entry (entering)	5	12	20	
3. Weaving in circulatory roadway	44	42	47	
4. Rear-end at entry	38	44	39	
5. Rear-end at exit	2	3	3	
6. Wrong direction in circulatory roadway	0	0	0	
7. Single vehicle run off circulatory roadway	15	21	20	
TOTAL	104	124	129	
CONSEQUENCES OF TRAFFIC ACCIDENTS				
	2008. y.	2007. y.	2006. y.	
1. Killed	0	0	0	
2. Injured	14	19	22	
TOTAL	14	19	22

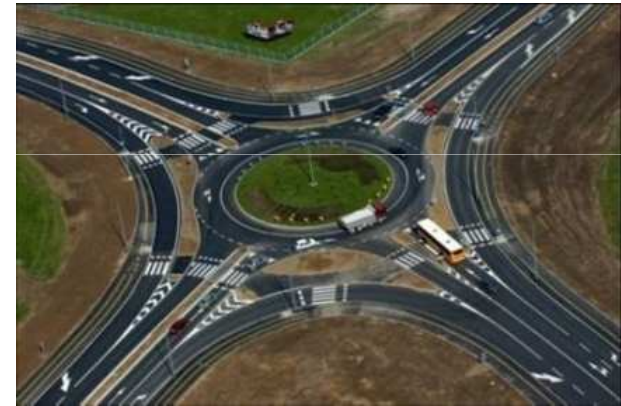
Figure 3. New solution of roundabout,
(Varaždin - bypyss south, 2005.)

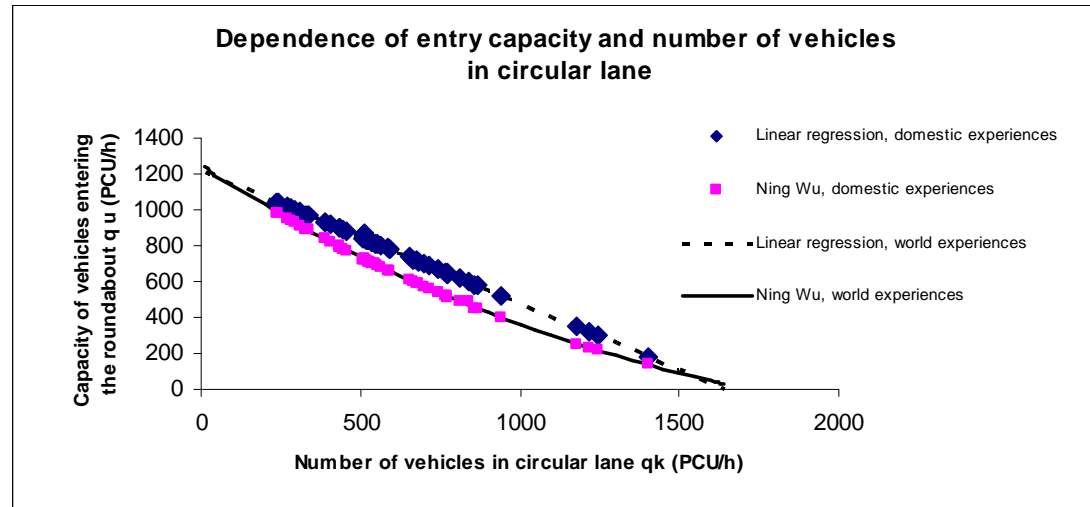
Figure 4. Measured q_u/q_k (Linear regr., Ning Wu) in world and in Croatia

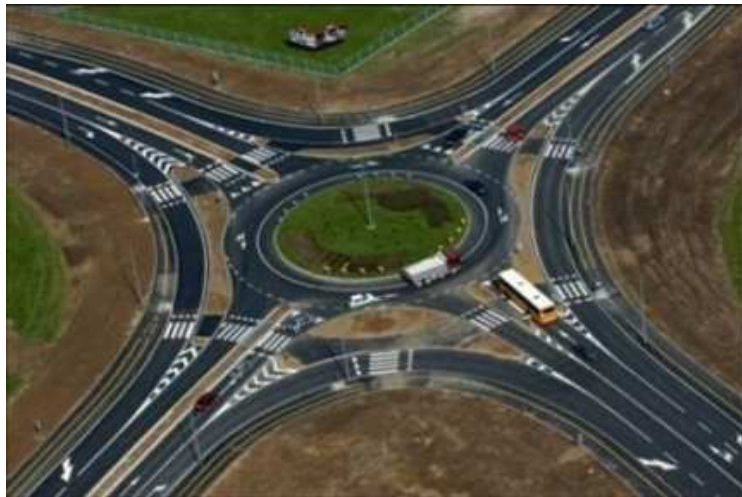
Figure 6. Direct weaving of cars, bicyclists and pedestrians by independent guiding (Varaždin bypass, 2005)
