LISBOA 2010
MAY 25/28
16th World Meeting

Use of Ground Penetrating Radar (GPR) Survey to Enhance Network Level Life Expectancy Analysis and Rehabilitation Design

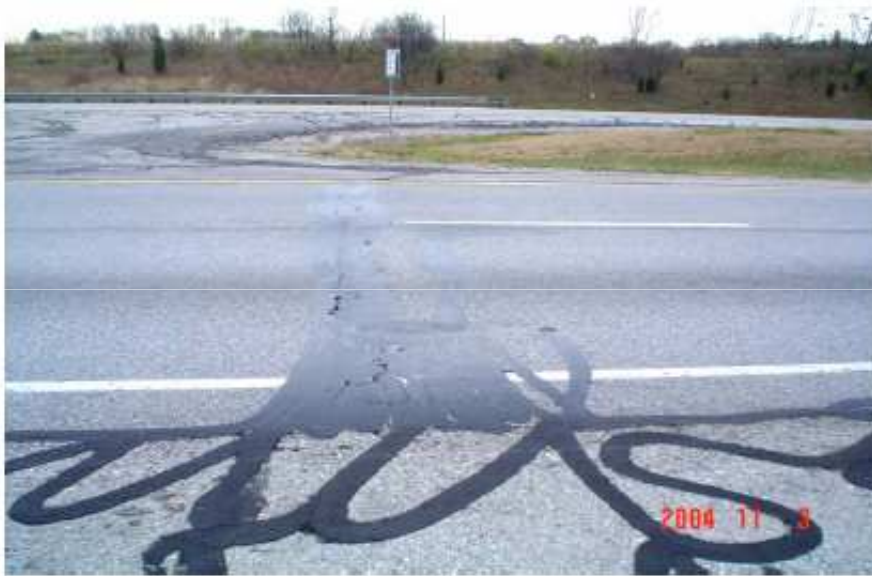
Figure 5a. Visual survey – Joint recommended for “Full Depth Repair”

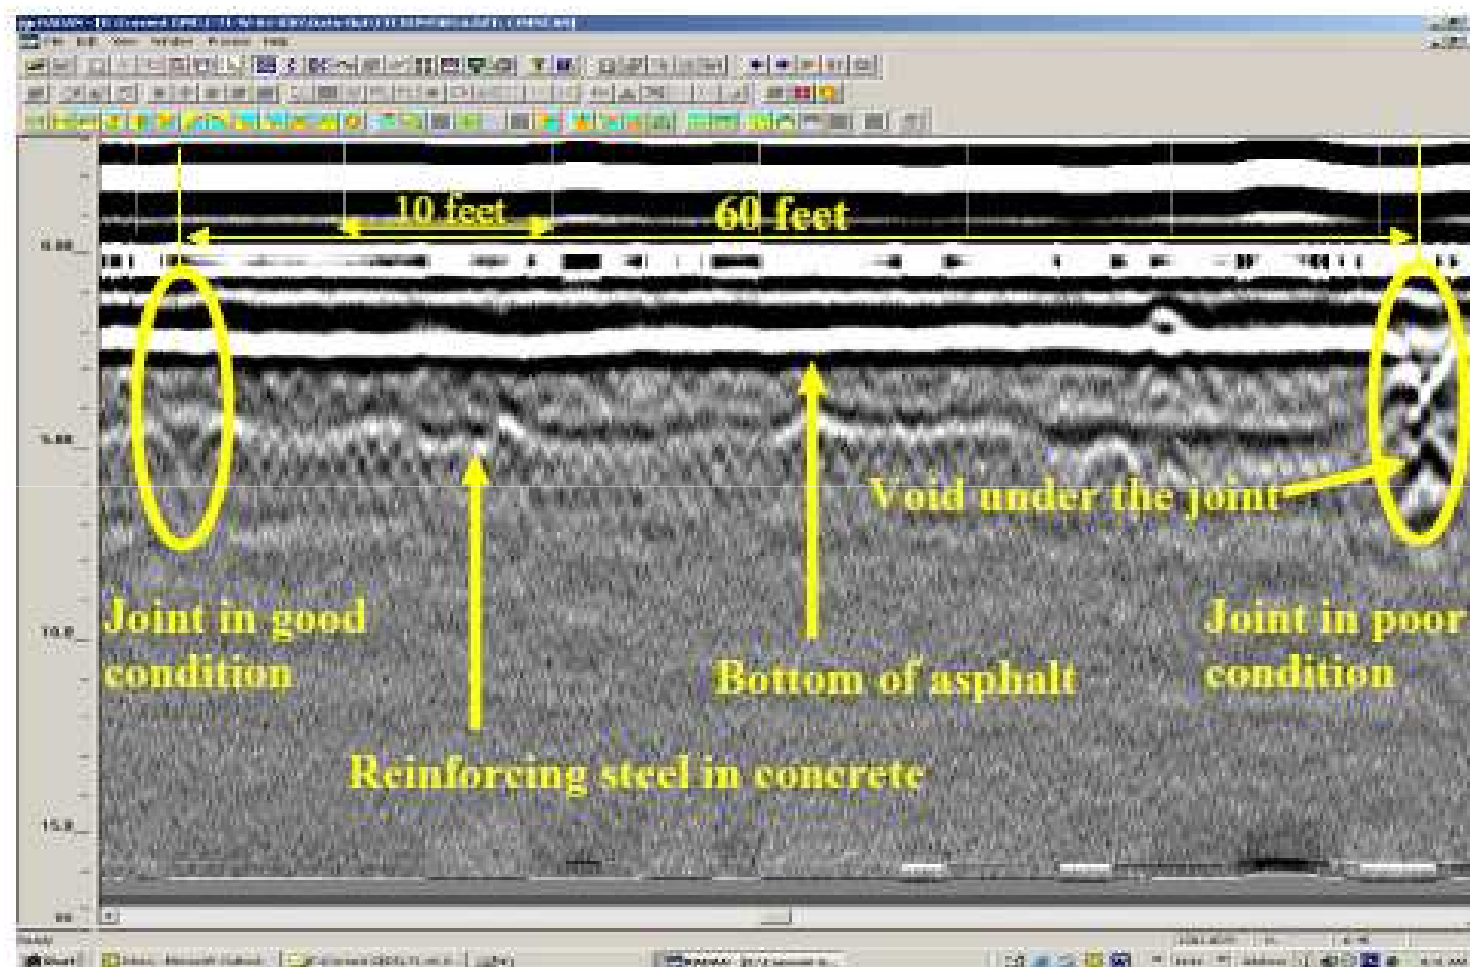
Figure 2. Typical GPR scan showing the condition of the transverse joints

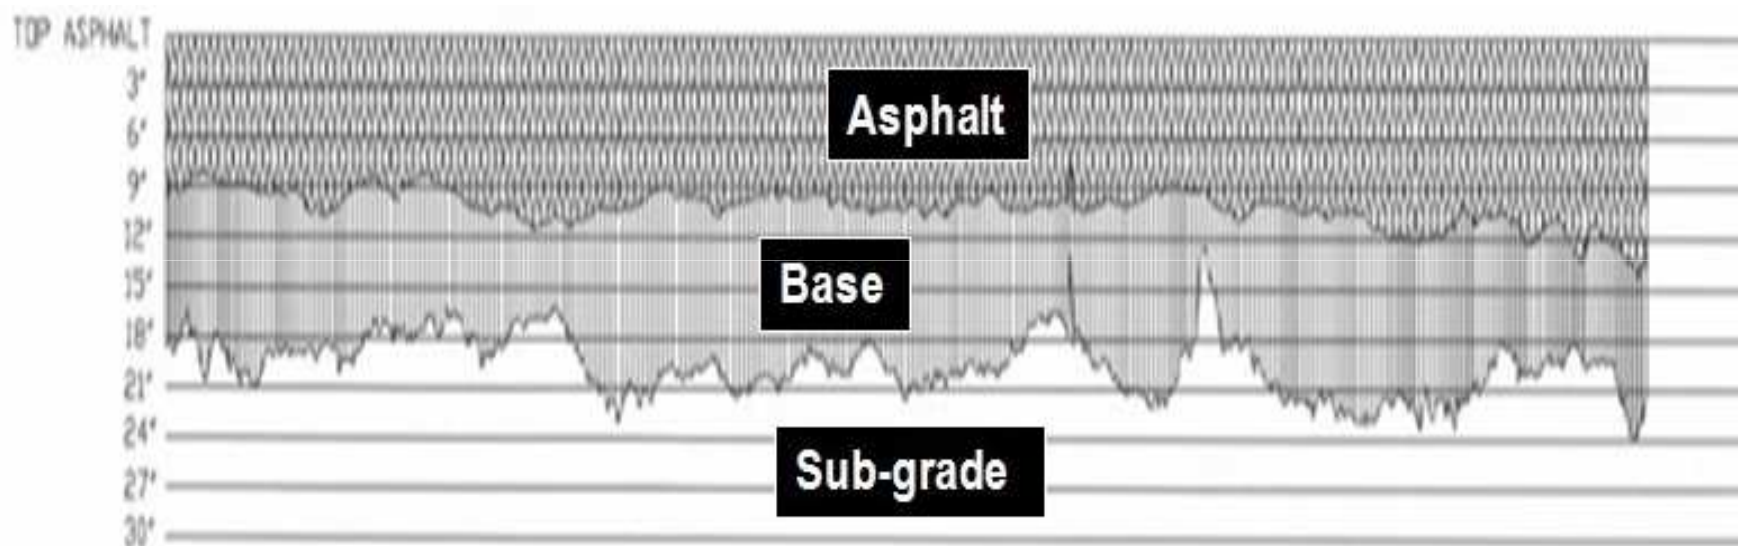
Pavement Thickness Survey

Hamilton-Mason Road, Butler County, Ohio
Longitudinal Section Along Pass #7

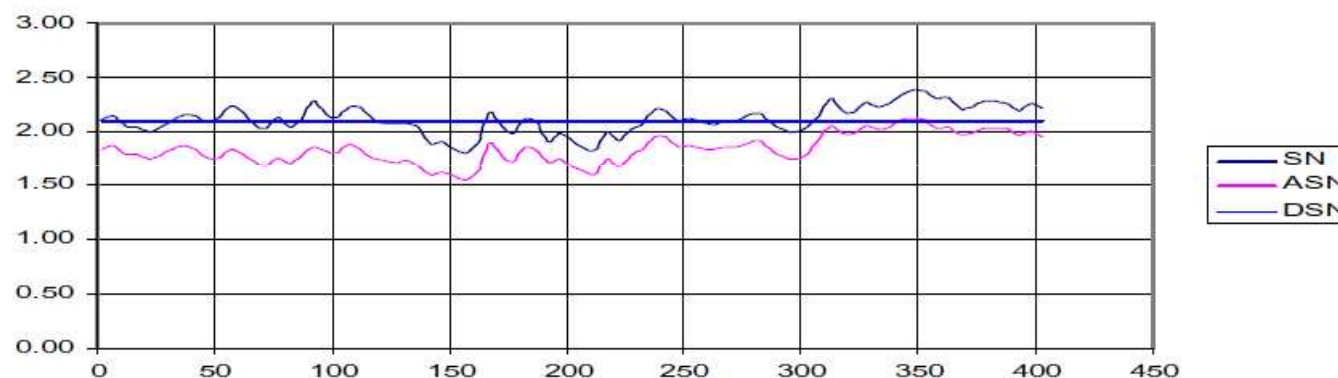
Pavement Structural Number

SN: Structural number

ASN: Adjusted structural number

DSN: Design Structural number

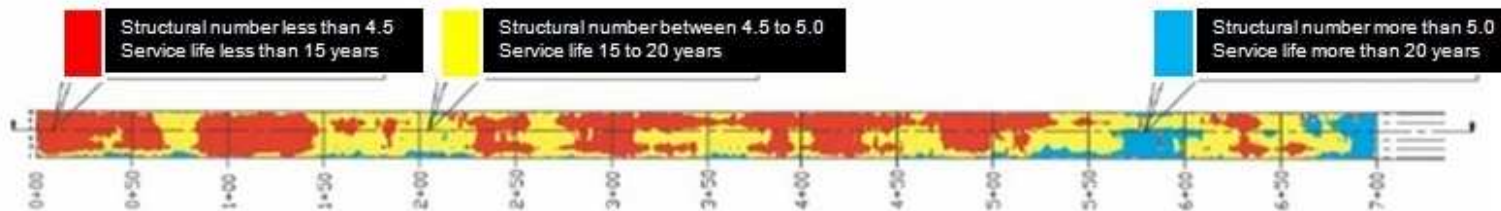
Pavement Service Life Plot

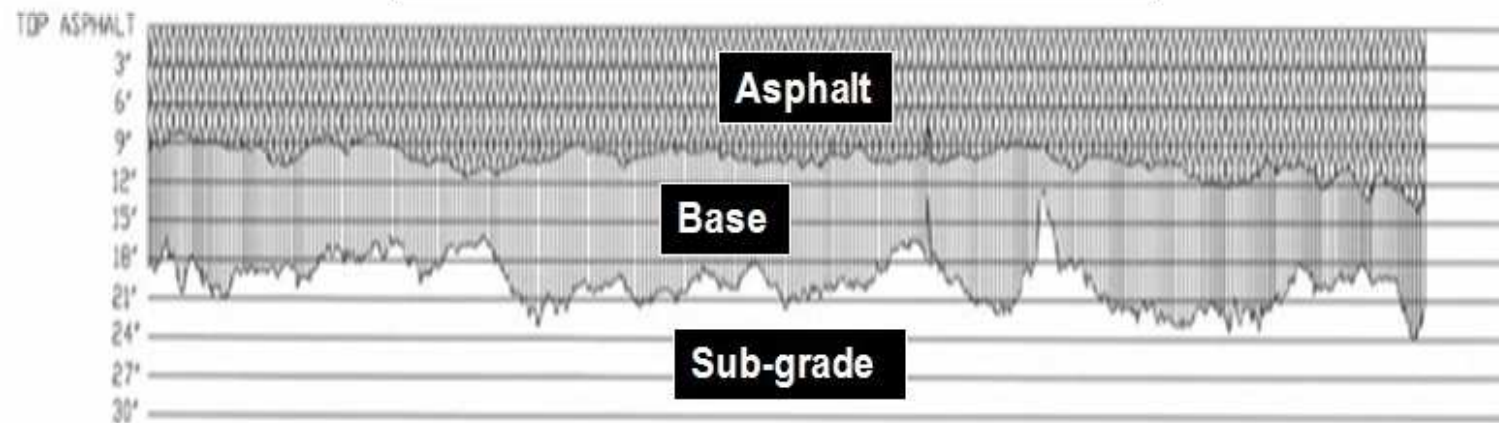
Pavement Service Life Plot- Eastbound Lane

Hamilton-Mason Road, Butler County, Ohio
Longitudinal Section Along Pass #7
