LISBOA 2010 MAY 25/28 16th World Meeting

Ivan Legac, Hrvoje Pilko, Nikola Šubić
University of Zagreb - Croatia

Introduction of Roundabouts in Croatia – - preliminary Experiences

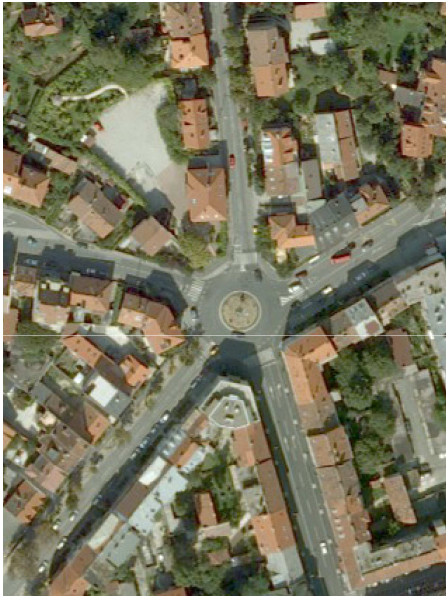
Figure 1. One of the oldest roundabout (Petr. – Domj. Str. in Zagreb, 1950)

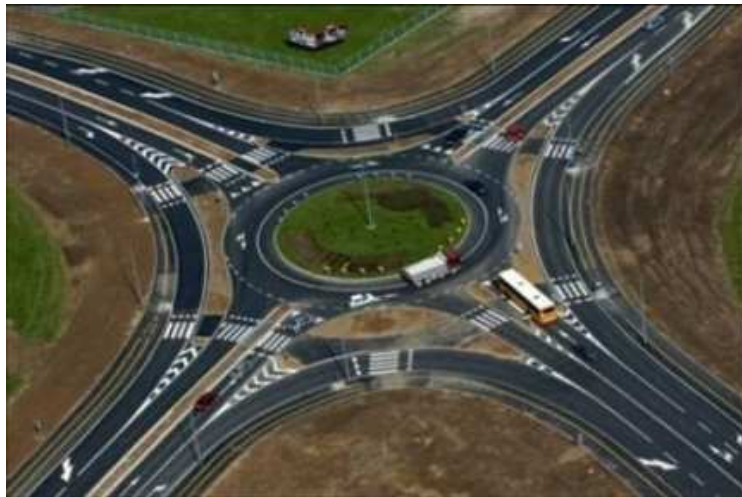
Figure 6. Direct weaving of cars, bicyclists and pedestrians by independent guiding (Varaždin bypass, 2005)
